November 1, 2024

Re: Indoor Air Quality Testing
Nantucket High School
10 Surfside Road, Nantucket, MA 02554
RPF File 240327

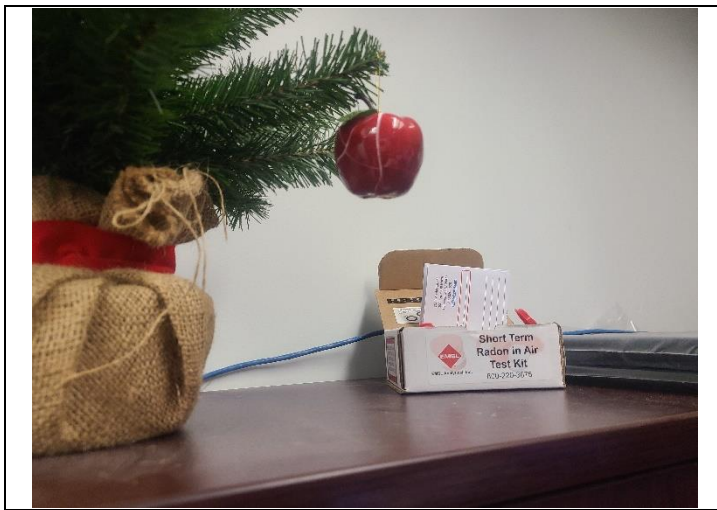
2. Tech Office, Lower-Level radon sample.

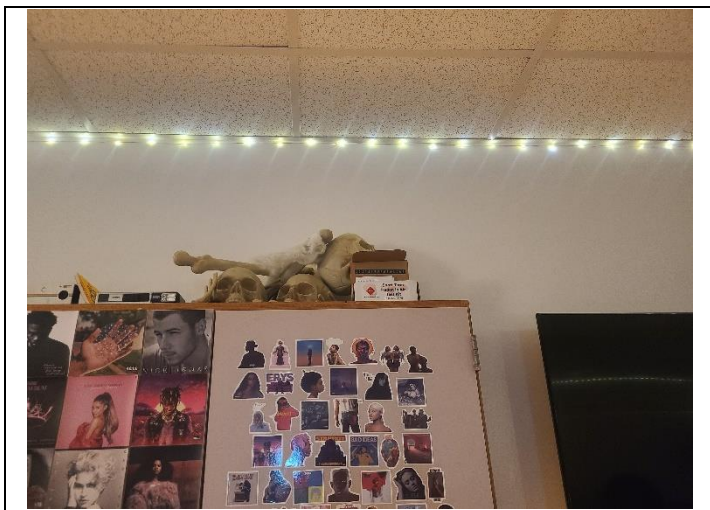
3. Room 005 radon sample.

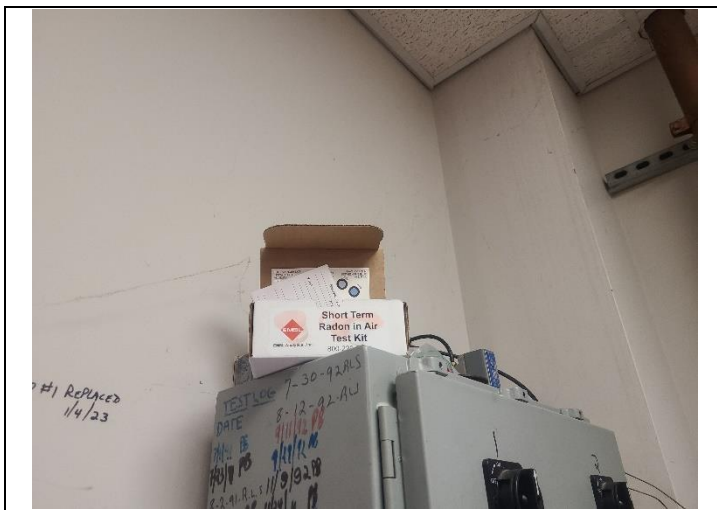
4. Room 015 radon sample.

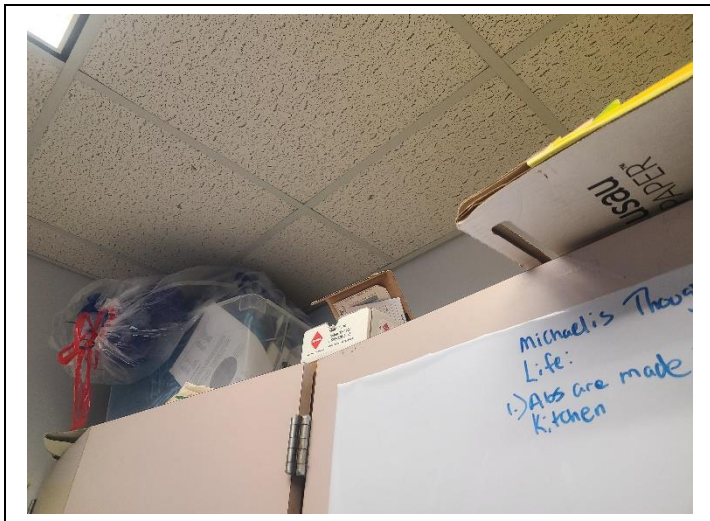
5. Room 009 radon sample.
