November 1, 2024

Re: Indoor Air Quality Testing
Nantucket High School
10 Surfside Road, Nantucket, MA 02554
RPF File 240327

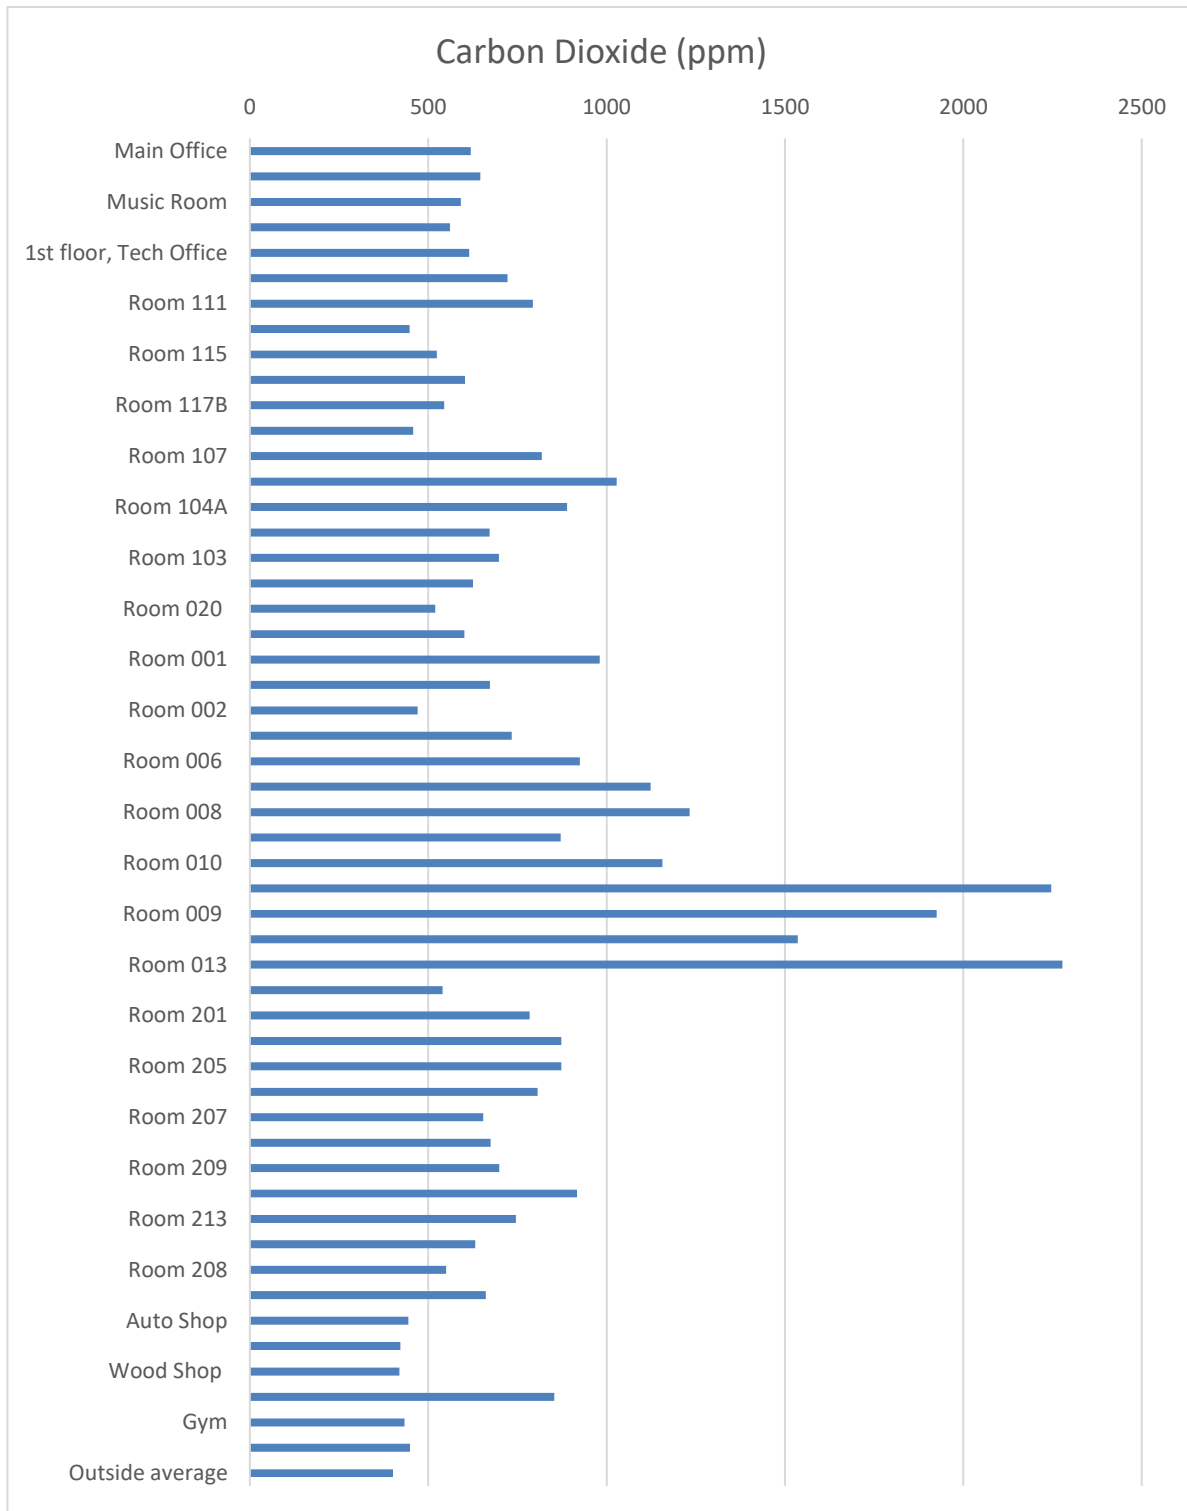
The CO₂ results and testing locations are presented in Appendix A. CO₂ levels at all indoor locations tested were documented in the range of approximately 419 to 2,778 ppm, which is well below the Occupational Safety and Health Administration Permissible Exposure Limit (OSHA PEL) of 5,000 ppm. These concentration ranges are elevated above the generally accepted guideline limit of 800 to 1,000 ppm.

The Commonwealth of Massachusetts Bureau of Environmental Health Assessments (BEHA) has an IAQ standard for the state office buildings of 800 ppm for acceptable CO₂ in occupied office buildings and 600 ppm or less for schools, which can be used as a reference value.

The feasibility of increasing the volume of fresh outside air to the lower level should be investigated.

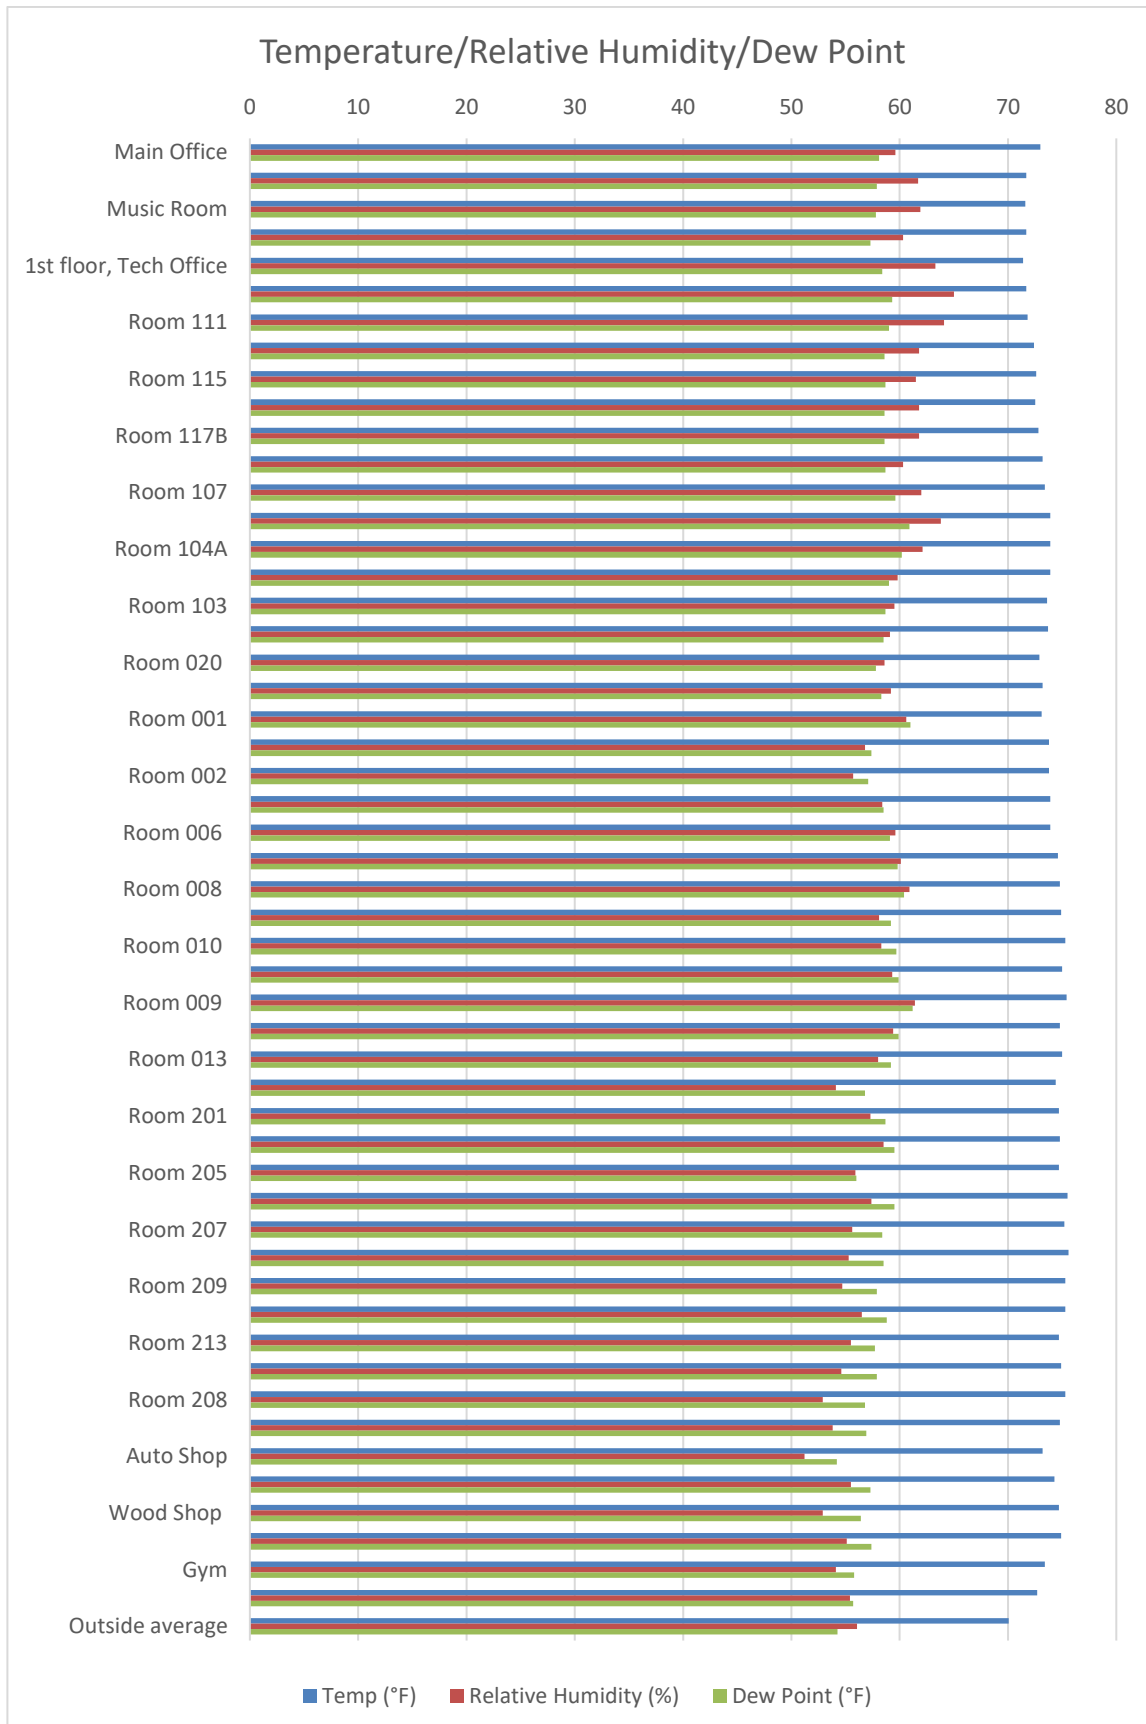
Temperature will affect the occupant's perception of IAQ based on employee comfort levels, effect of drafts or airflow, and humidity levels in a building. In most cases, simple adjustments to thermostats and direction of airflow from registers can improve the perceived IAQ. As a reference, the temperatures recommended by ASHRAE for general office space range from approximately 68° to 75° Fahrenheit in the winter, and from approximately 75° to 80° Fahrenheit in the summer. Temperature readings at all indoor locations tested were documented in the range of 71.4° to 75.6° Fahrenheit.

The amount of water vapor that can be contained in the air varies by the temperature and pressure of the air. The ratio of water vapor in the air to the maximum amount of water vapor the air can hold at a given temperature is expressed as relative humidity (RH). The recommended RH comfort range is 35% to 55%. In general, for buildings, the presence of excessive moisture can lead to mold growth and other biological contaminants. Low RH, common for buildings in New England during colder months, may contribute to irritated mucous membranes, dry eyes and sinus discomfort while high relative humidity, common in summer, may cause discomfort, as it hinders the body's use of perspiration as a cooling mechanism. RH levels at the indoor locations tested during this survey were mostly above the generally accepted comfort range.

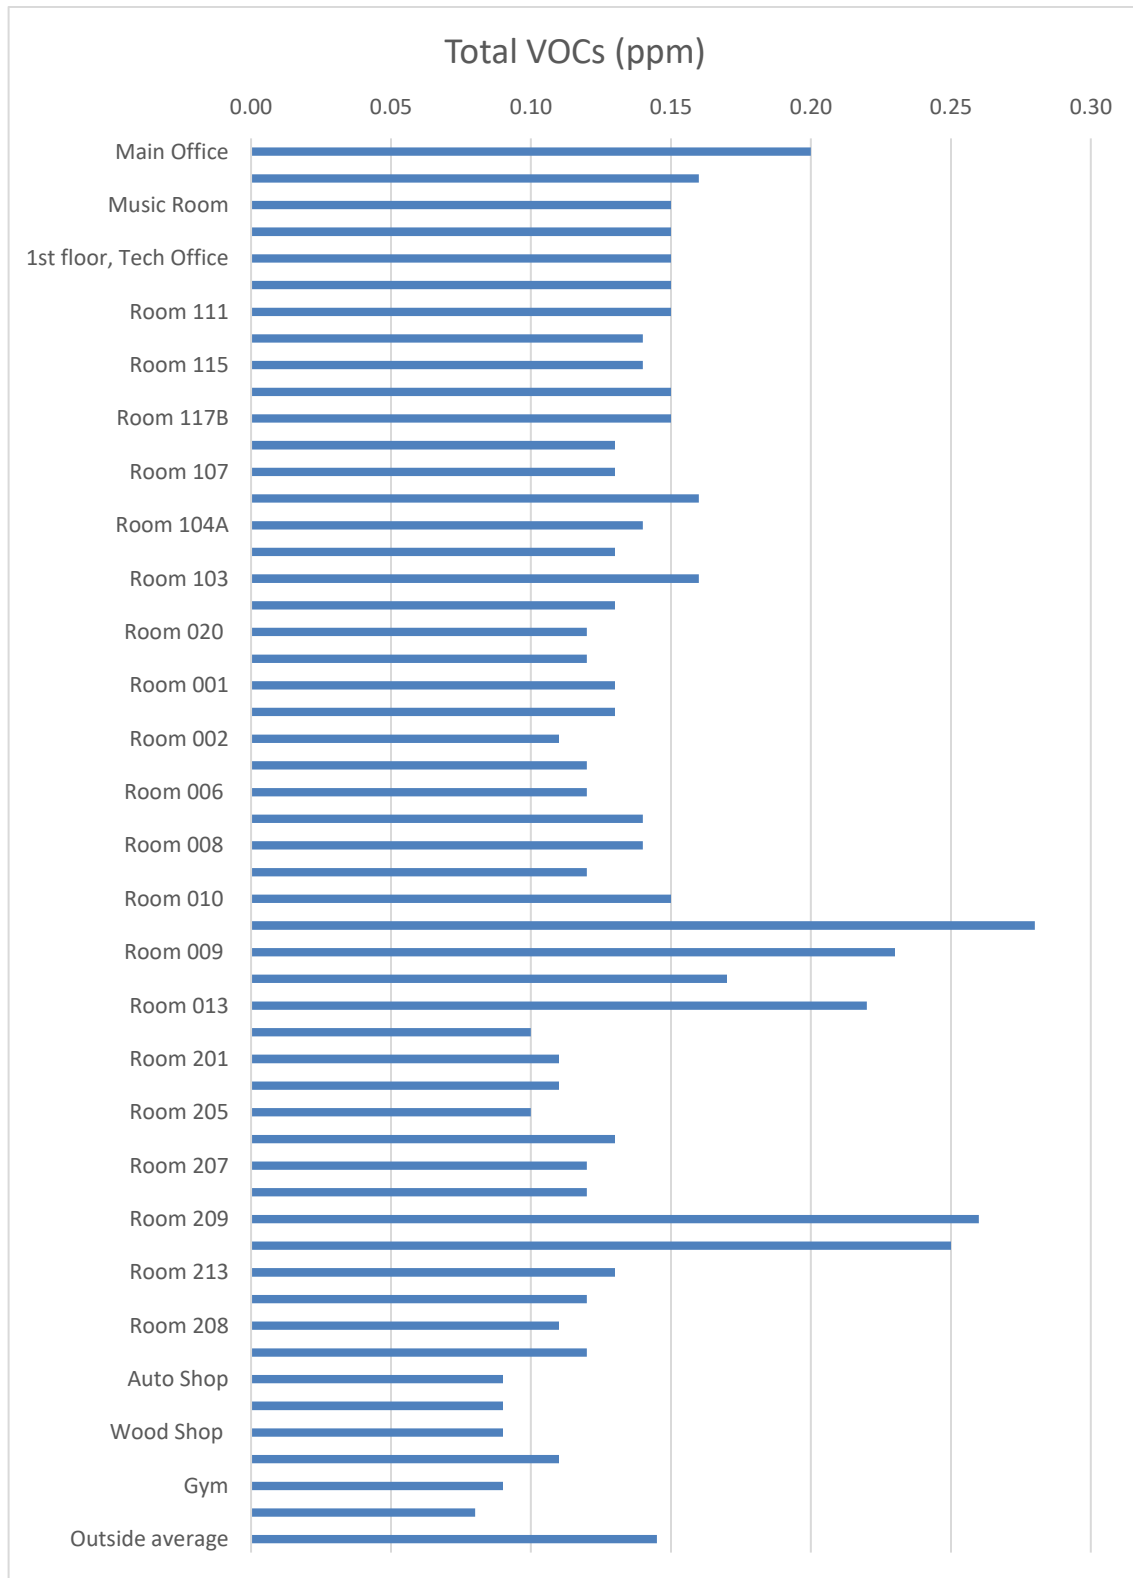
The scope of this survey included screening for total volatile organic compounds (VOCs). During this testing, total VOCs were measured at 0.28 parts per million (ppm) or less for all locations. These readings are within the "normal indoor air" range depicted below and are comparable to the outside air, which had an average reading of 0.145 ppm. These results are summarized below and presented in Appendix A.

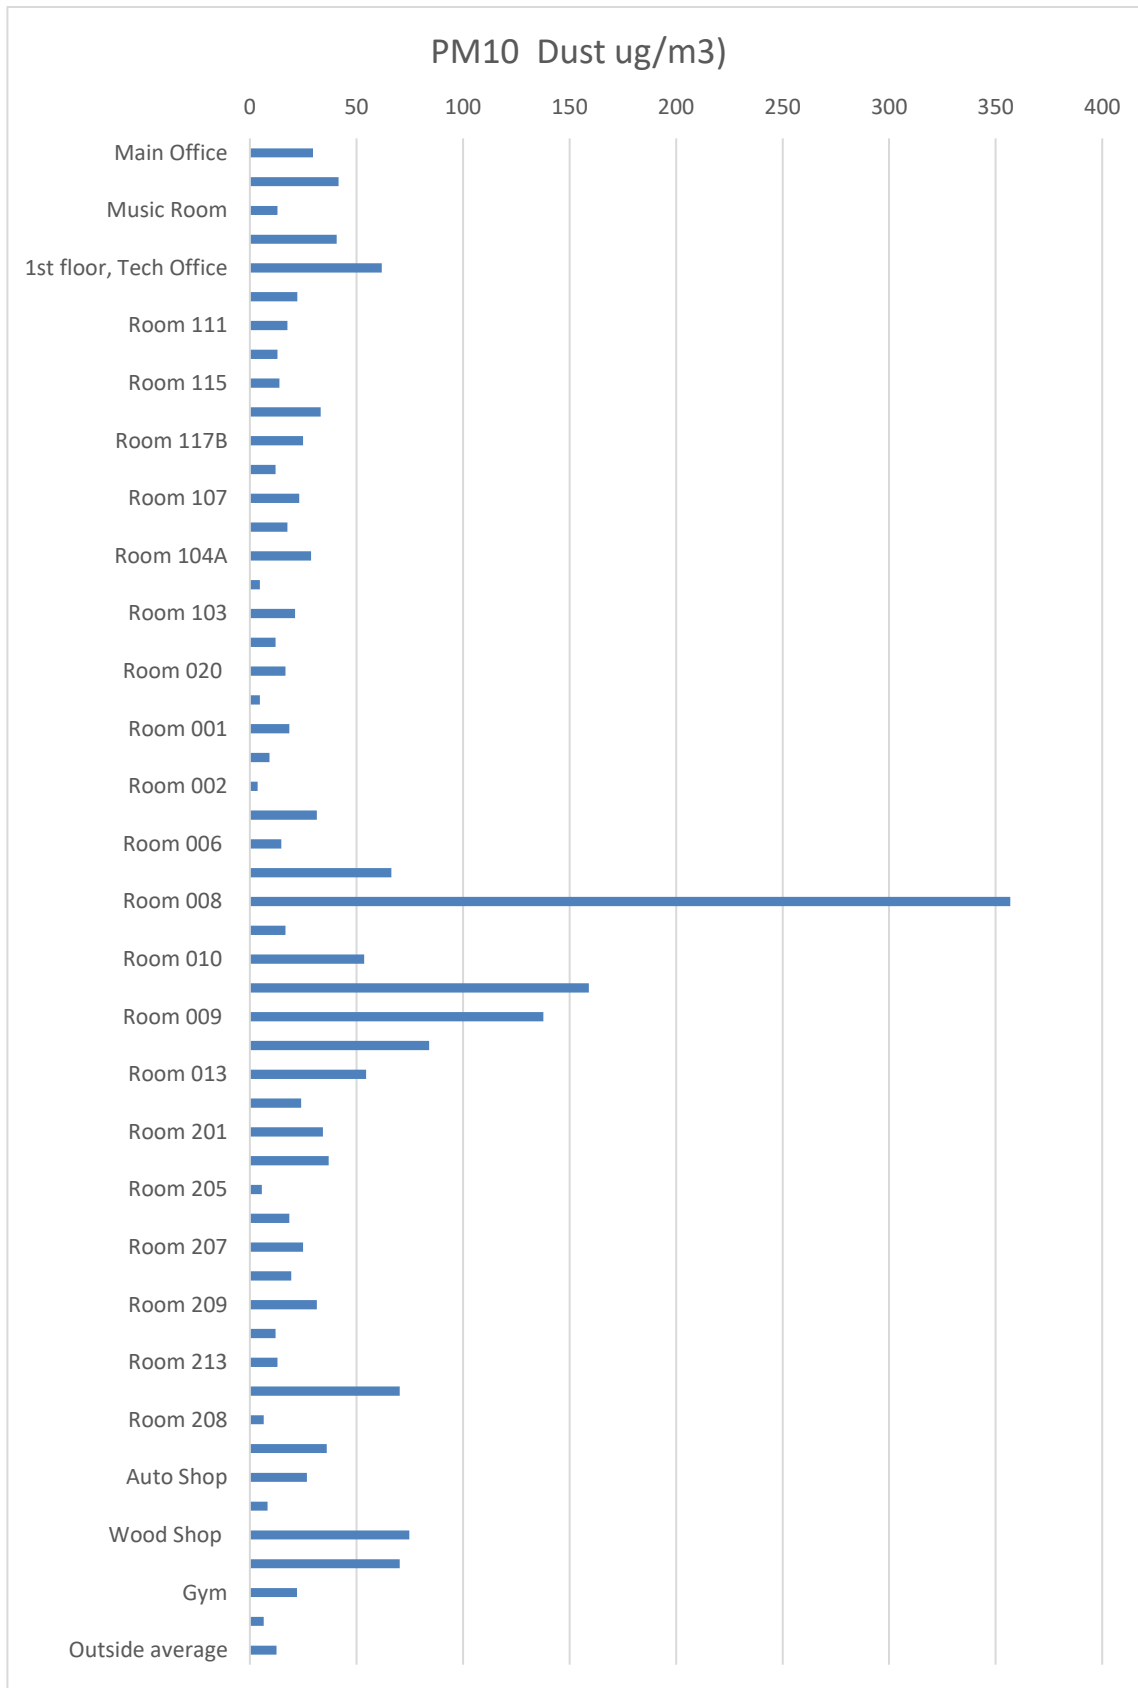
Direct reading determinations for PM₁₀ at all indoor locations tested were in the range of approximately 3.70 to 356.87 micrograms per cubic meter of air ($\mu\text{g}/\text{m}^3$). The results at most of the interior locations tested were elevated above the values found outside, which was approximately 12.48 $\mu\text{g}/\text{m}^3$. The US EPA does have a National Ambient Air Quality Standard at 150 $\mu\text{g}/\text{m}^3$ which was exceeded during the testing. The World Health Organization (WHO) also has set a standard of 50 $\mu\text{g}/\text{m}^3$ as a 24-hour average and 25 $\mu\text{g}/\text{m}^3$ as an annual average exposure. These results and testing locations are presented in Appendix A.

These results indicate that the HVAC filters are not reducing the overall particle loading inside the building when compared to the outside air. For a building that implements the use of an HVAC system, it is typical to see a 25% to 35% reduction in total particulates inside a building compared to the outside concentration of particulates while the HVAC units are operational. The feasibility of upgrading the HVAC systems' filter efficiency rating could be investigated if complaints were to be increased at this building. The American Society of Heating, Refrigeration, and Air Conditioning Engineers (ASHRAE) has recommended filter minimum efficiency reporting value (MERV) of not less than six (6) for filters in HVAC systems supplying air to occupied office space (ASHRAE Standard 62.1-2004-5.9). Follow the manufacturer's recommendations for a filter change out schedule.

- There were PM10 readings within the building that were elevated above the outside readings. Most of the readings collected within the building were well below the NAAQS of 150 ug/m³, except for readings collected in Room 008 and Room 007, which were above the standard. RPF recommends the feasibility of increasing/adding FOA to these areas. As indicated above, investigating the feasibility of upgrading the filters to a better MERV rating (such as MERV-13) could help make the system more efficient in removing particles.

Other steps to reduce indoor PM₁₀ concentrations include proper ventilation, away from HVAC intakes, combustion appliances to the outdoors, proper exhaust vents in cooking areas, proper use of wood stoves, and professional maintenance of heating systems.
