**Cyrus Peirce Middle School
12 Surfside Road
Nantucket, Massachusetts**

AHERA 3-YEAR REINSPECTION REPORT

July 2023

VERTEX Project No:89066

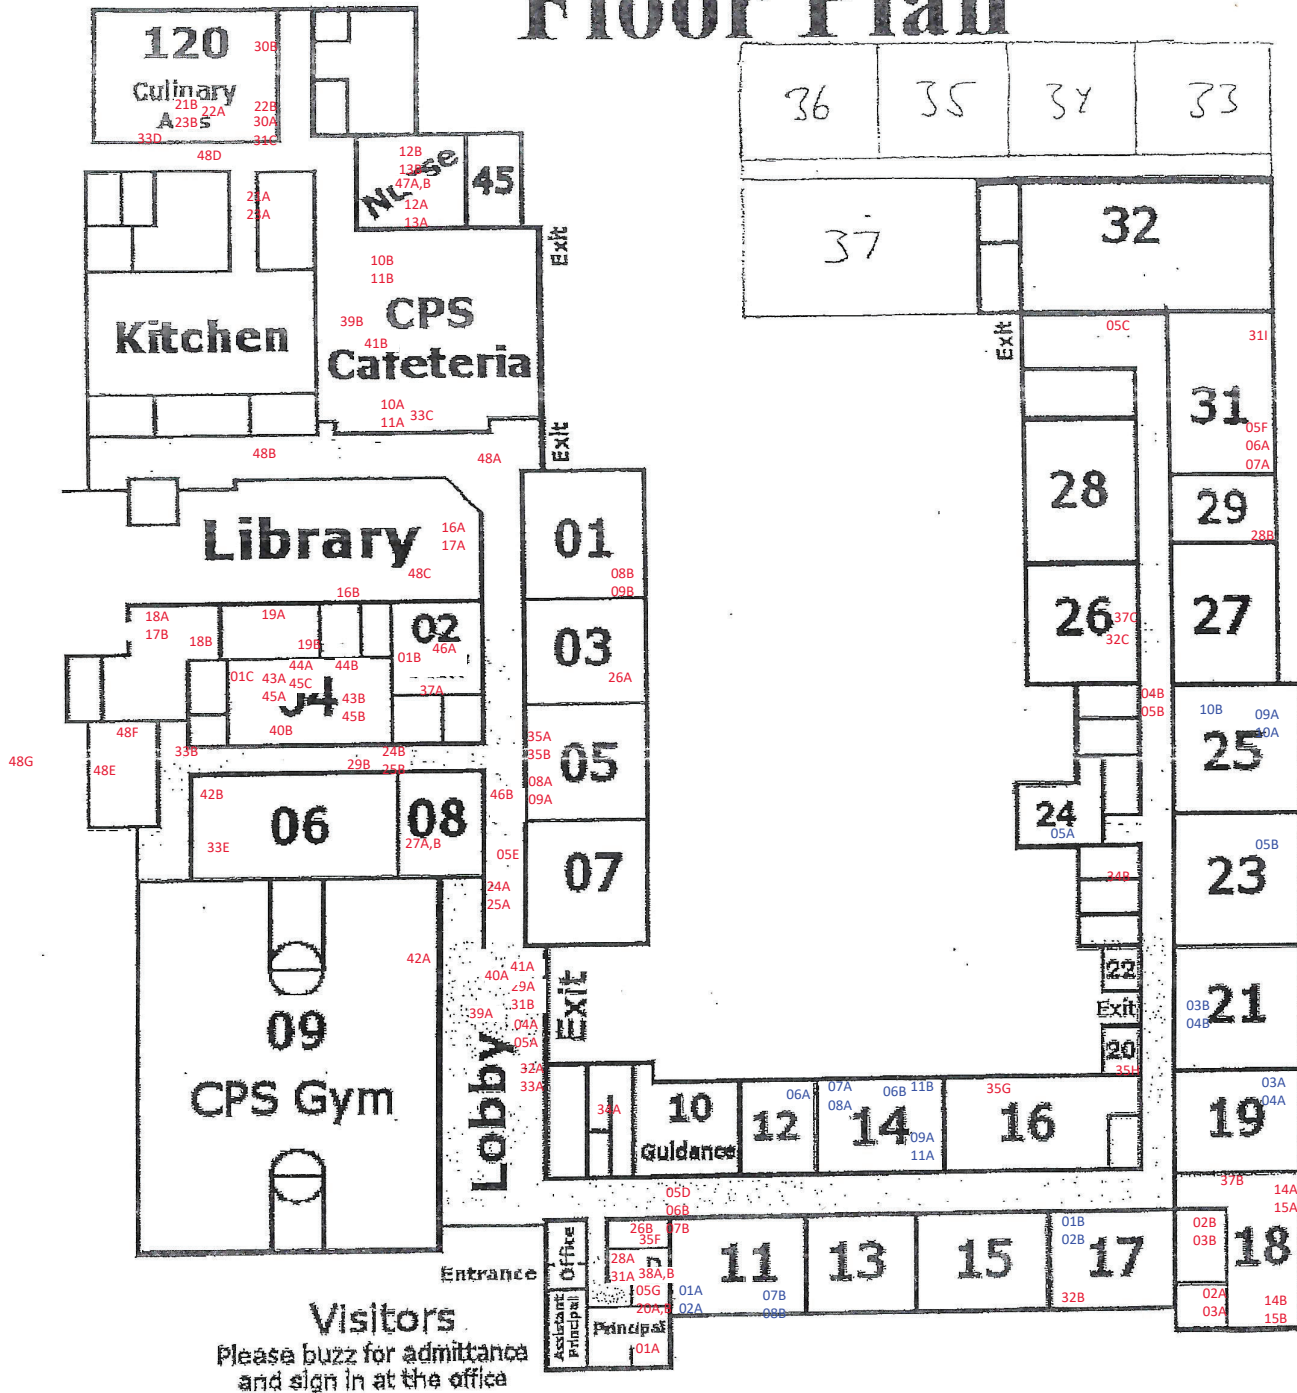
Floor Plan

BULK SAMPLE LOCATION (7/8/20) = 01A

BULK SAMPLE LOCATION (5/8/19) = 01A

Locations of the identified ACBMs with quantities observed, conditions assessed, homogeneous hazard assessment are presented in Appendix A of this report.
